DEVELOPMENT OF ADVANCED LIGHTWEIGHT SYSTEMS CONTAINMENT FINAL REPORT

MAY 1981

GENERAL ELECTRIC COMPANY

NASA Lewis Research Center
Contract NAS3-21823

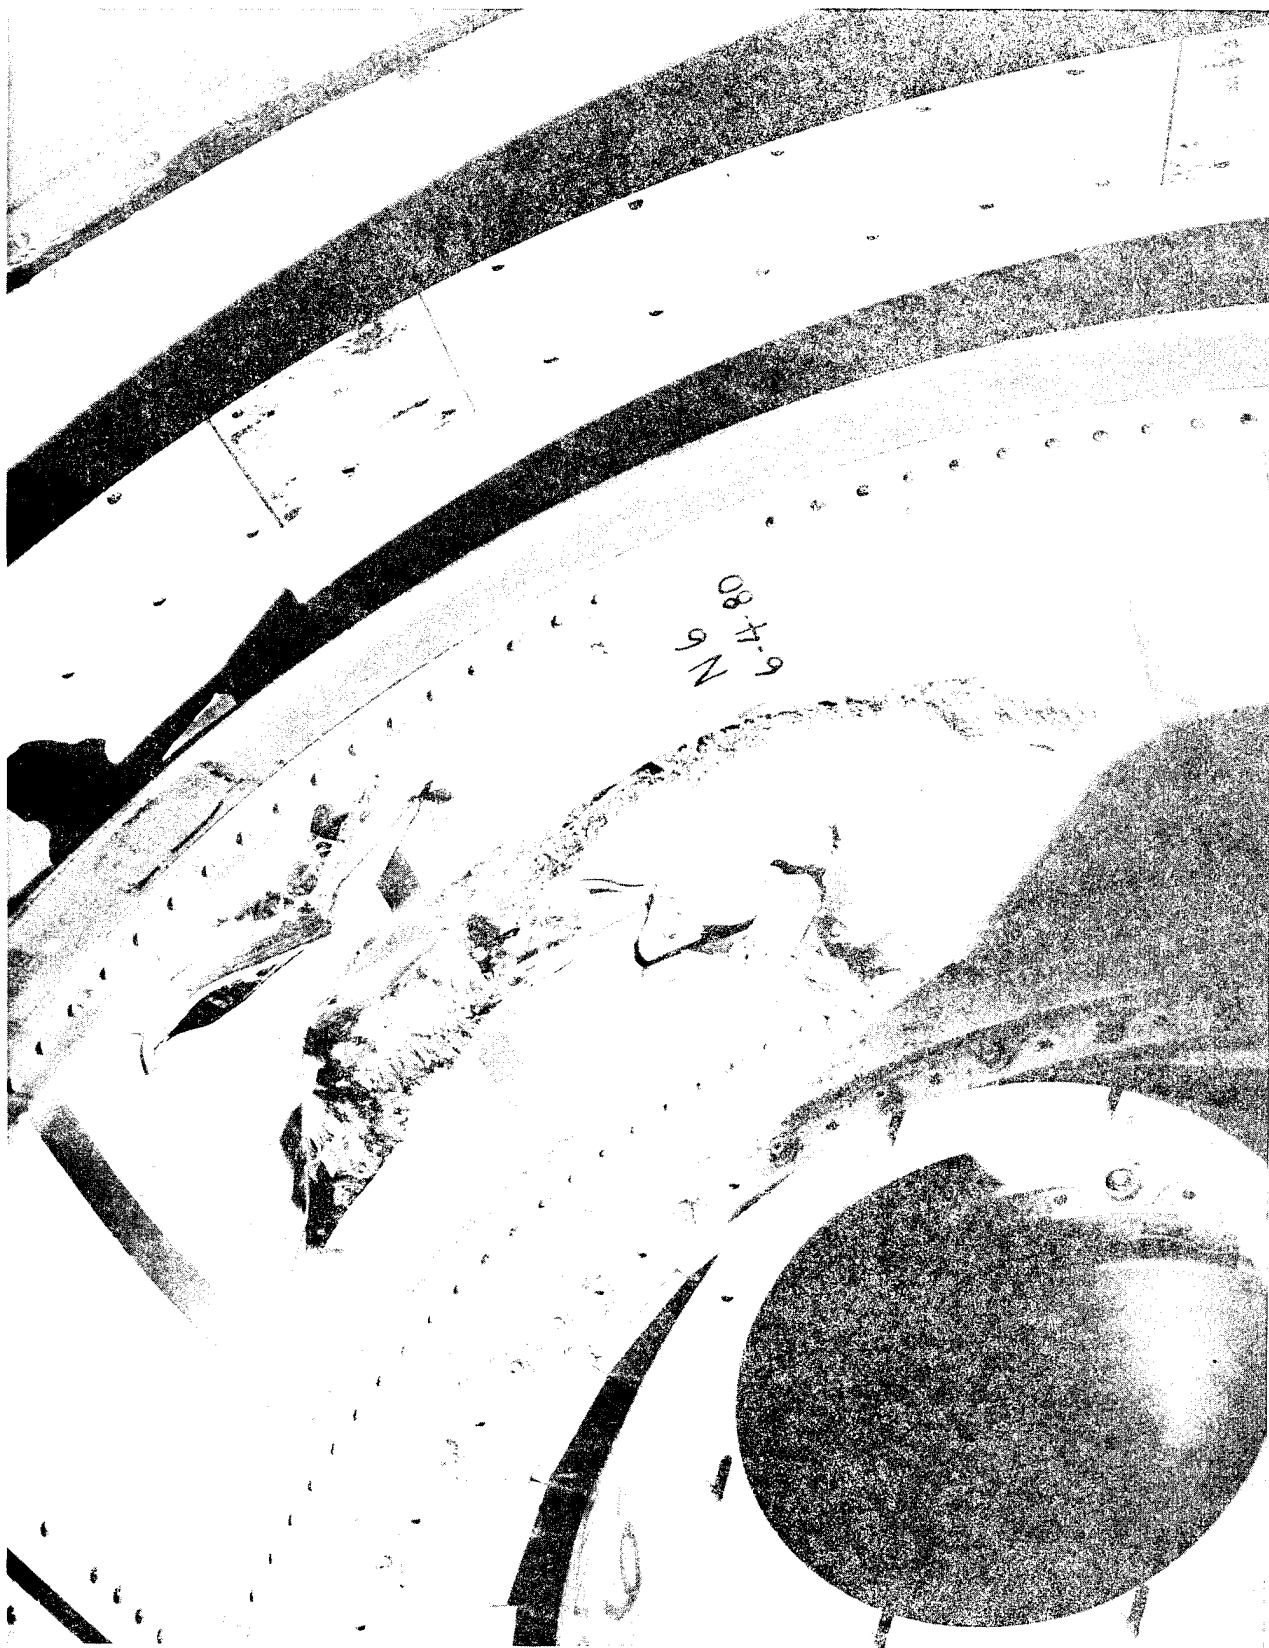
Figure 29. Aluminum Face Sheet - Test 6.

The change from steel to aluminum on the flowpath face sheet did not appear to have any effect on the containment process and the face sheet was not torn up by the impact any more than the steel face sheets used in previous tests run under similar conditions. Since there was no net rotor unbalance, there was no information generated on the rub capability of the aluminum face. The condition of the aluminum face at the impact point is shown in Figure 29 and the condition away from the impact points is shown in Figure 30.

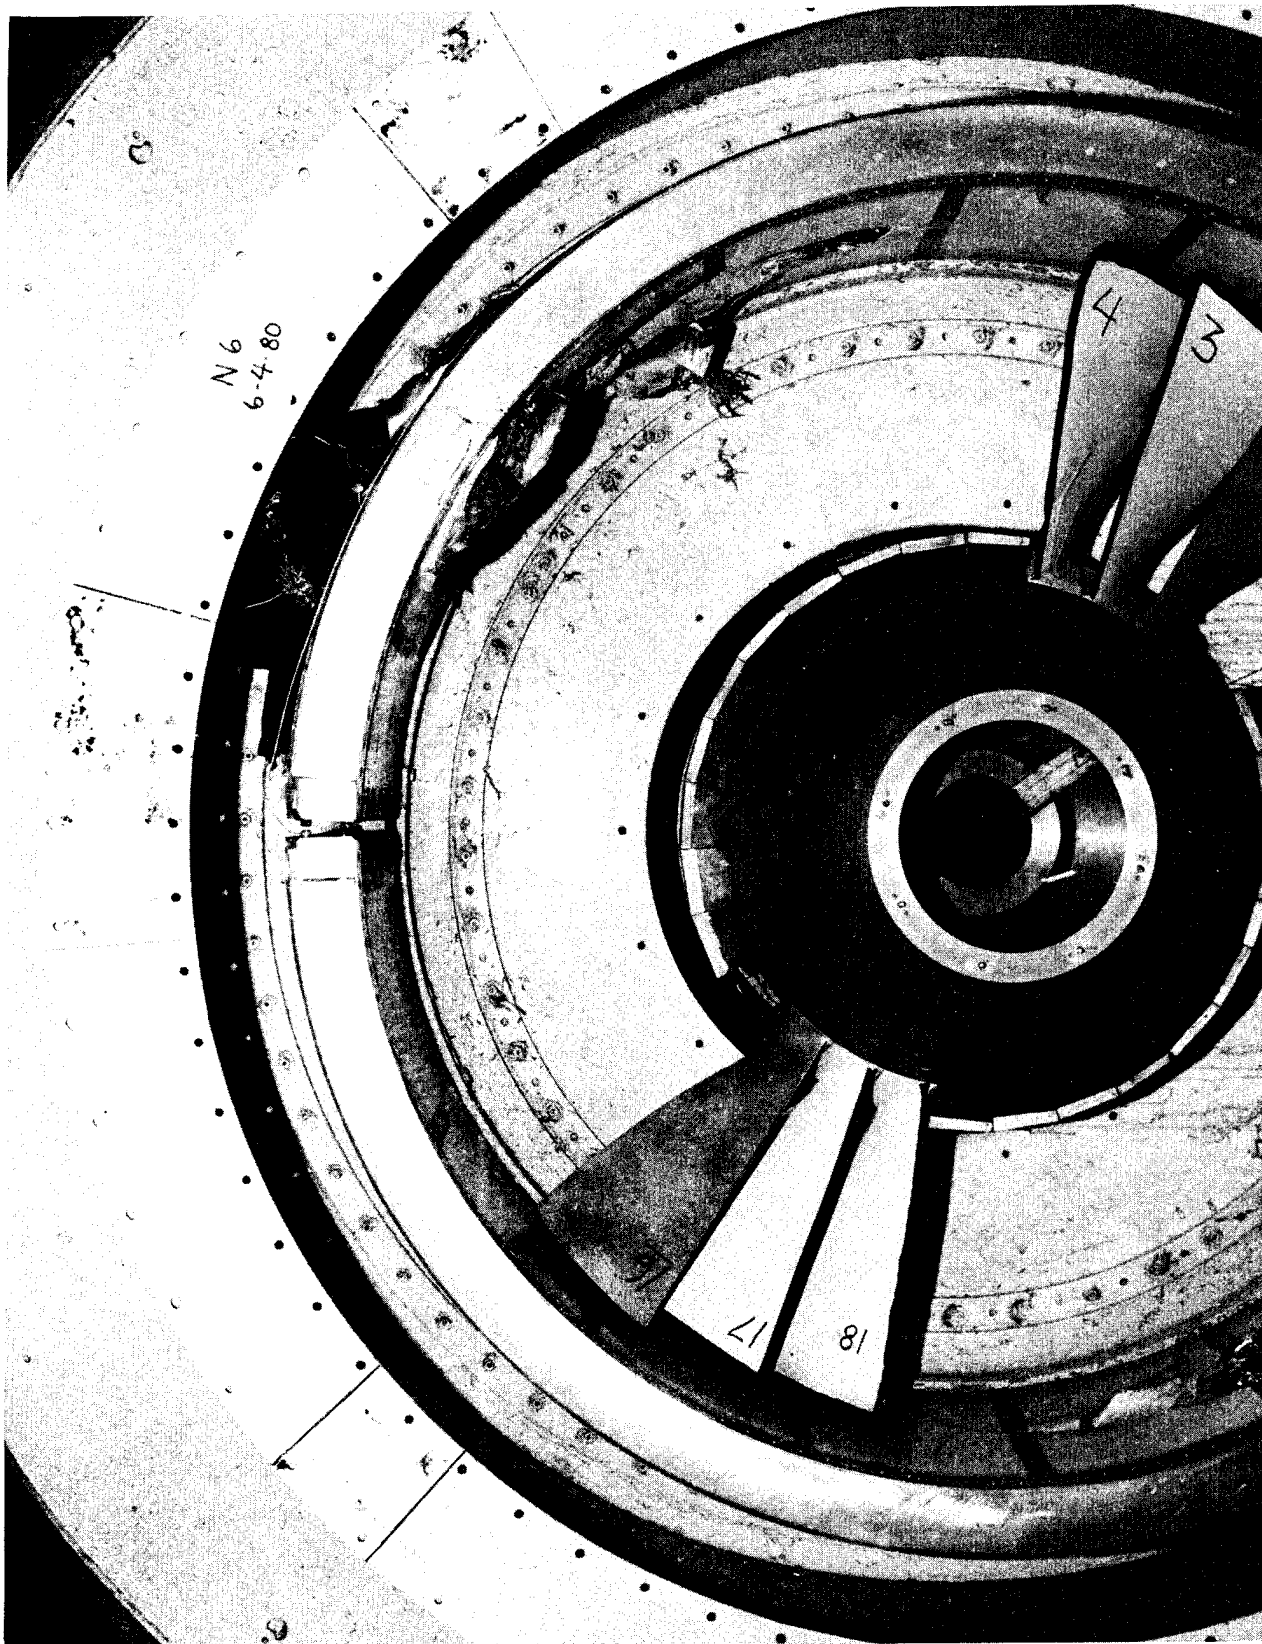
Figure 30. Test 6 - Overall View.

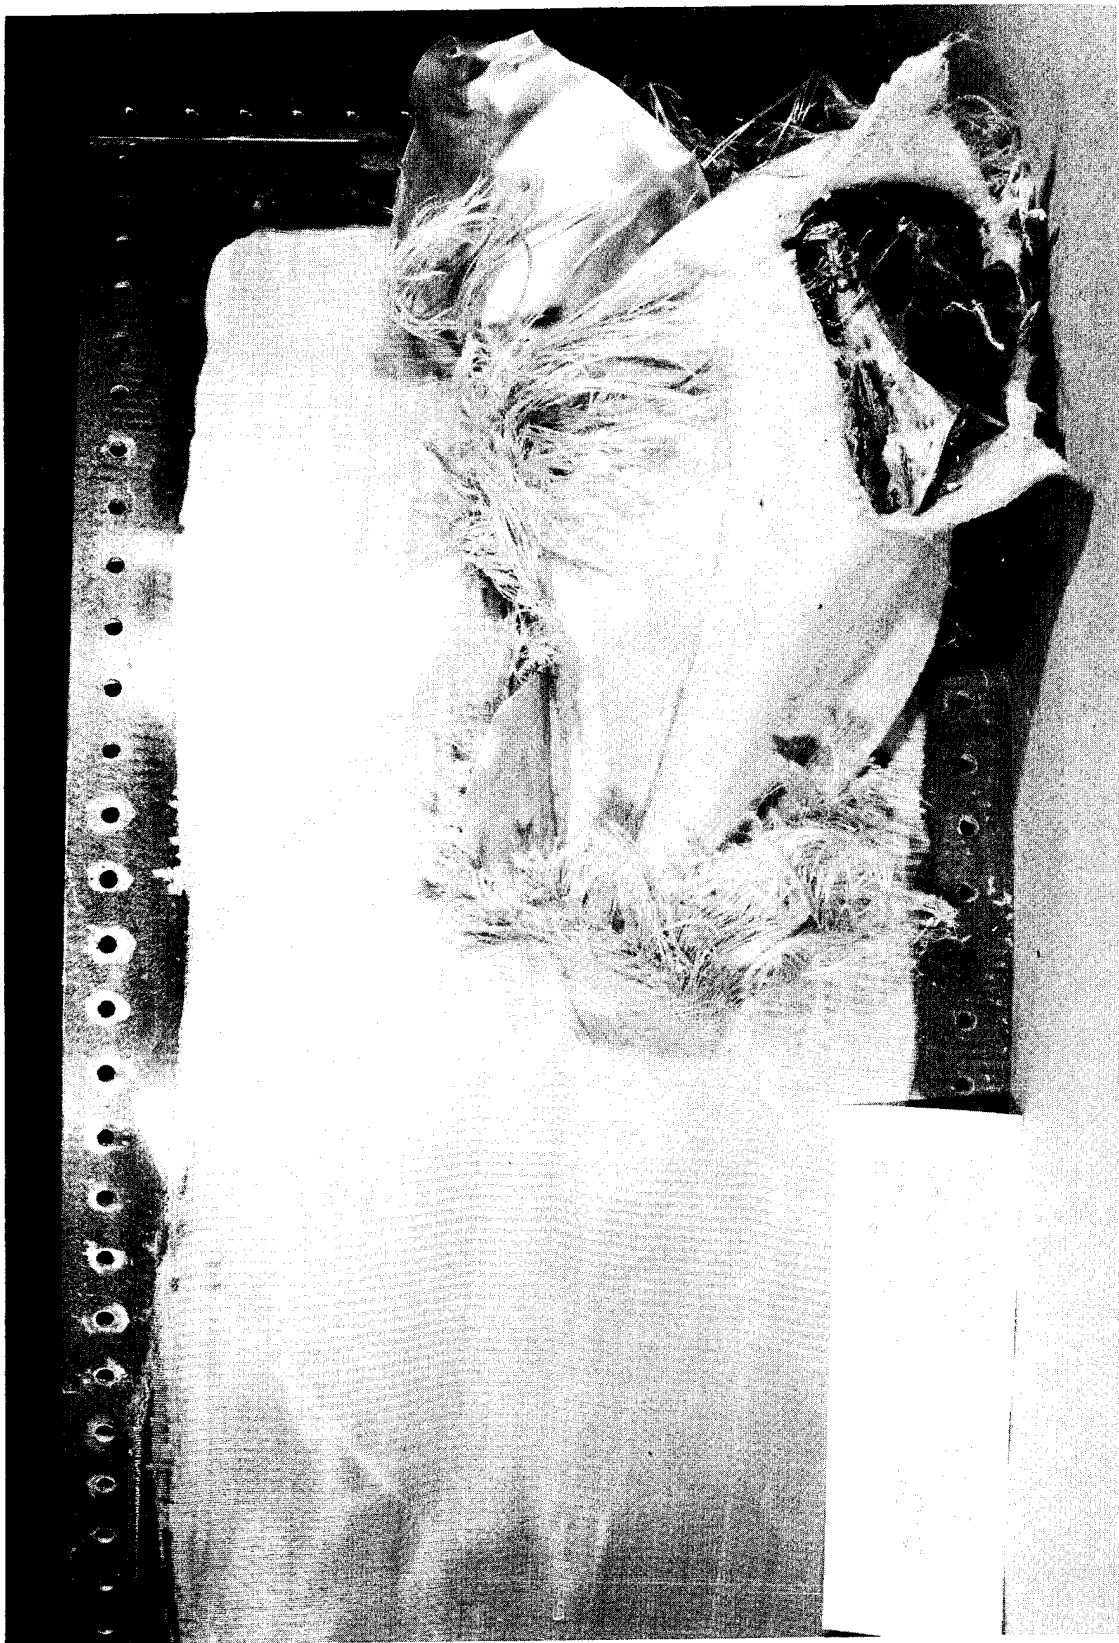
Figure 33. Exterior View - Test 8 - 143-Weave Cloth Plus Felt.

Although the heavier felt did not tear nearly as readily as the lighter felt used on previous tests, the blade roots punctured both the felt and the woven cloth on both specimens. As with the previous test using the 143-weave cloth, there was a splitting tendency due to the small number of transverse (axial) fibers allowing the released blade, encased in the felt except for the root section, to virtually escape from the containment system (Figure 33). The blade would probably have come out except that the root struck the witness plate preventing further radial motion. The damage to the witness plate can be seen in Figure 34. The system with 328 weave was not as severely penetrated but the root section did come completely through the containment in a manner similar to Test 7. Although the heavier felt may have helped some (compare Figure 35 which shows the damage from Test 8 with Figure 32 from Test 7), it was a marginal improvement. This blade too may not have been retained in the containment system if it had not struck the witness shield.

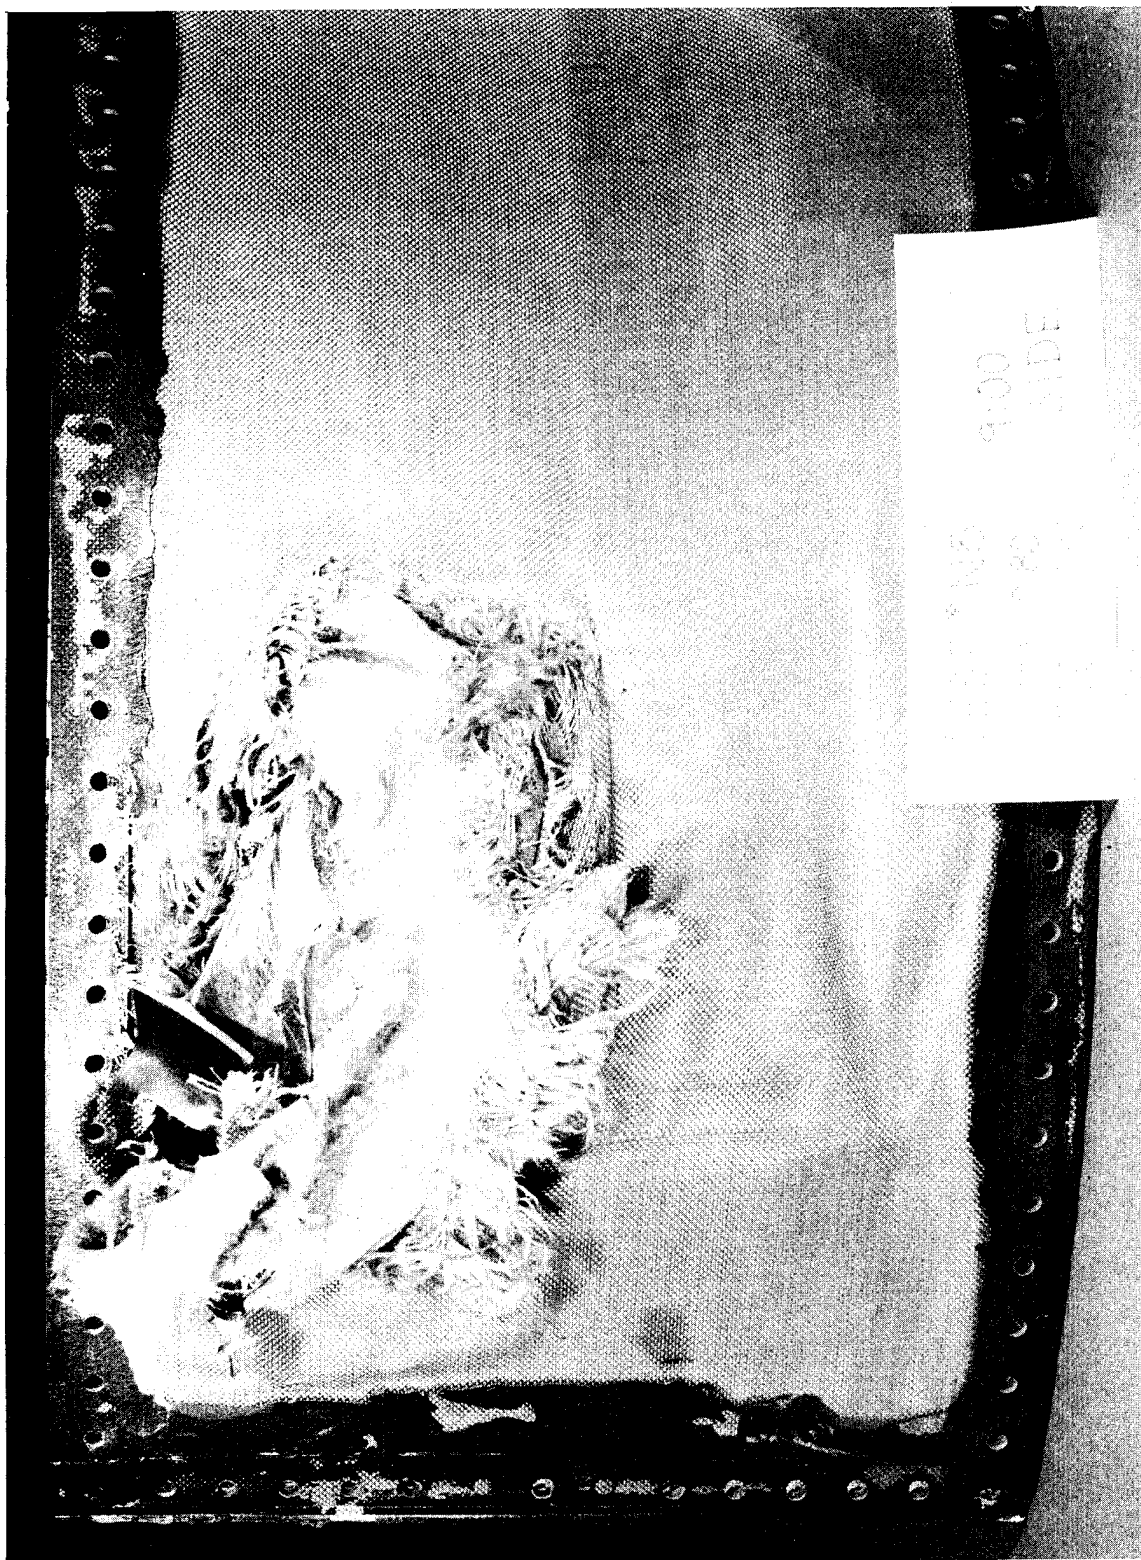
Figure 35. Exterior View - Test 8 - 328-Weave Cloth Plus Felt.

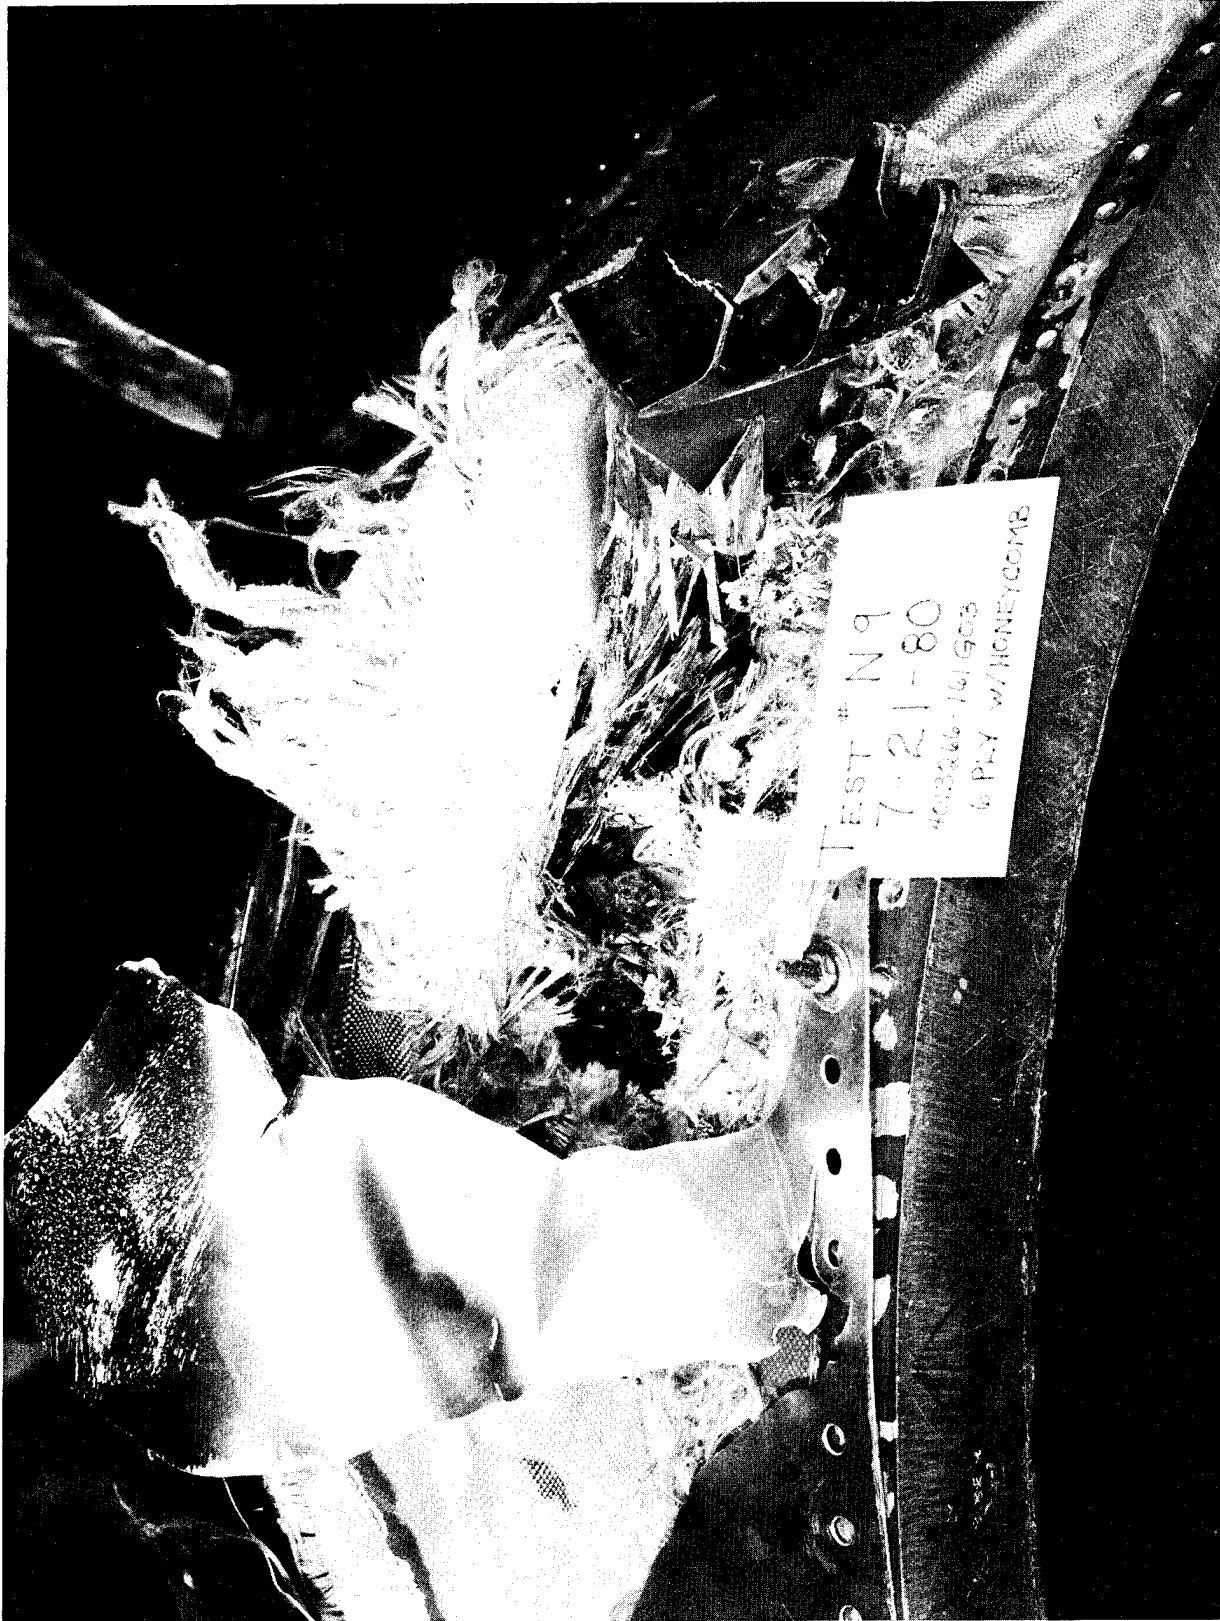
Figure 36. Exterior View - Test 9 - Six-Ply Side.

The two superhybrid blades were released below the platform at a rotor speed of 5300 rpm. The damage was severe to both systems. Due to the different weight distribution of the superhybrid blade, the motion of the released blade was somewhat different than that of the titanium blades previously tested. The superhybrid blade seemed to have a higher axial (aft) component to the impact force. On the side with six plies of Kevlar, the root section penetrated through the Kevlar and impacted the witness plate with significant force, but did not penetrate it. As can be seen in Figures 36 and 37, the root section was completely outside the containment system, and the composite portion of the blade was badly fragmented. Some of this composite debris trapped in the containment system can be seen in Figure 38. It is possible that the root section and attached titanium spar would have escaped the containment system if it had struck the witness plate. The six-ply containment system was therefore considered inadequate to contain a superhybrid blade under the conditions tested.

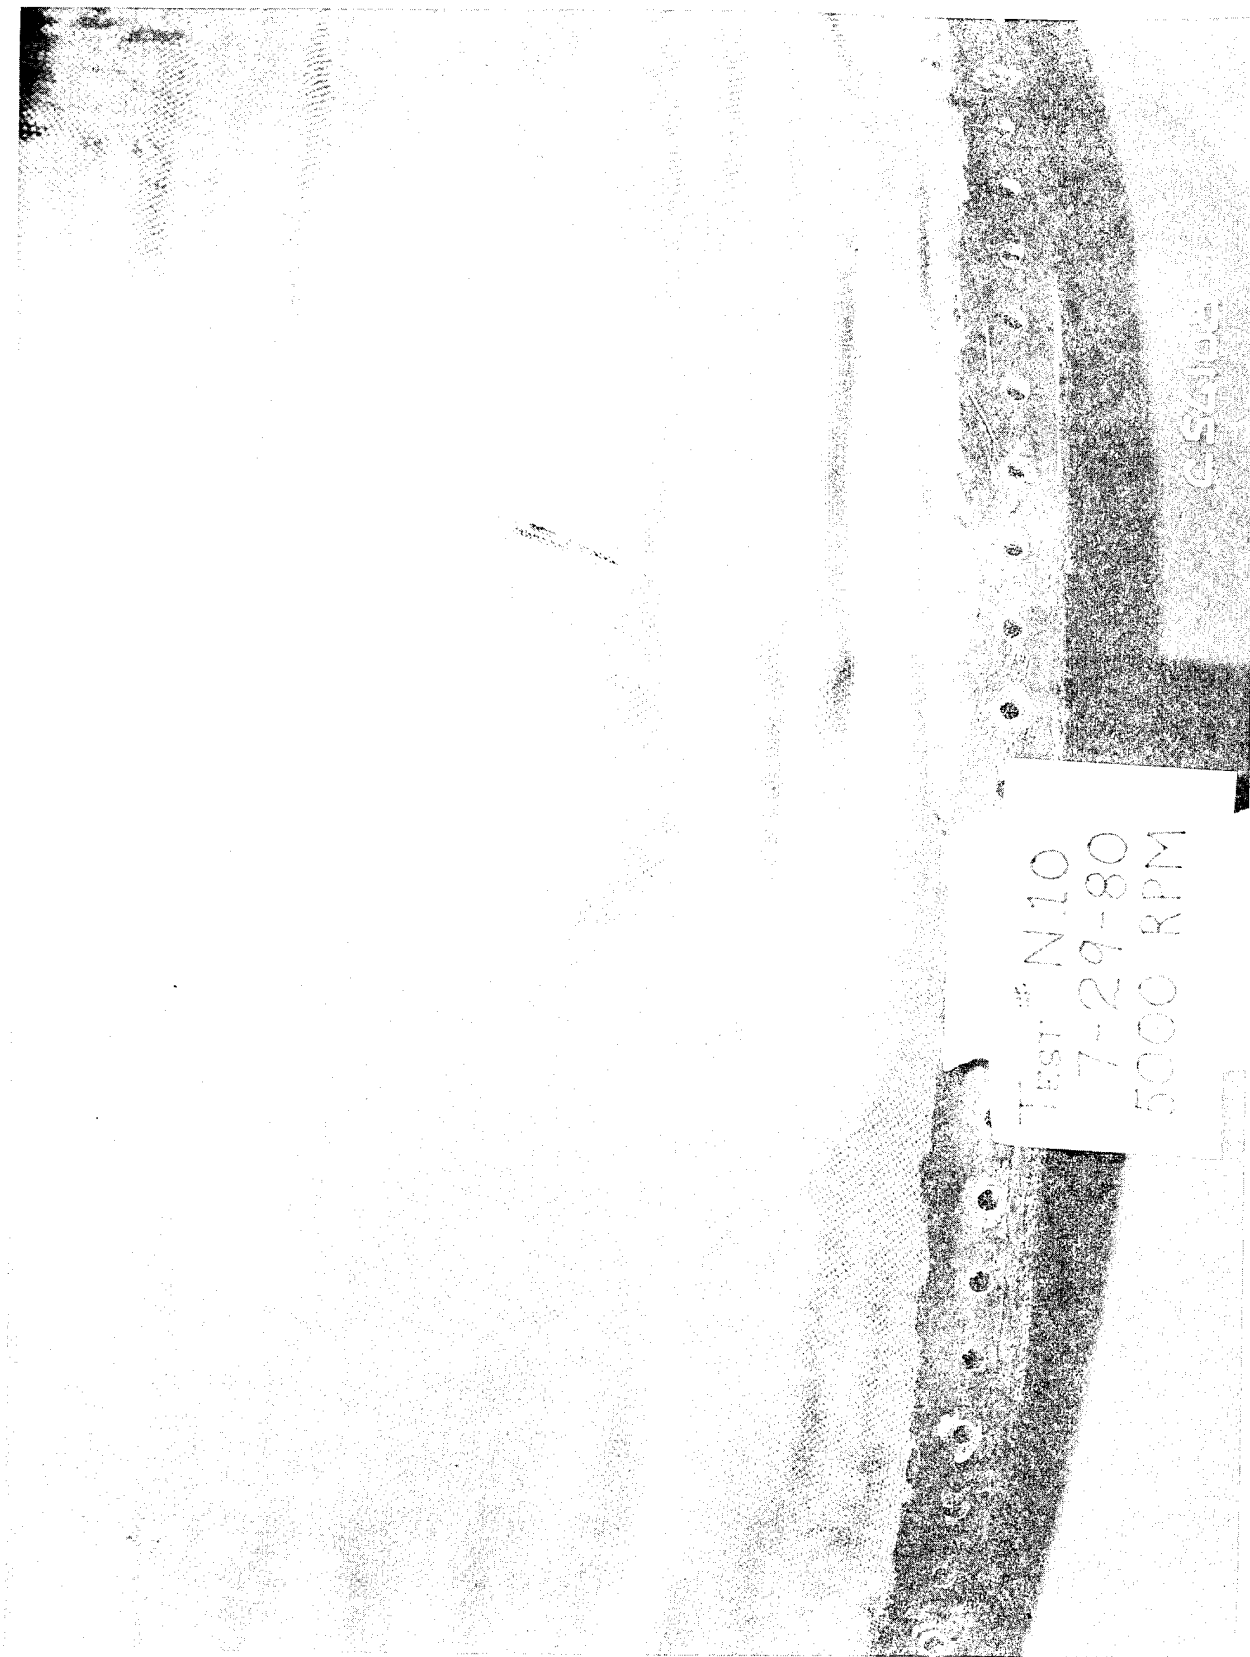
Figure 43. Exterior View - Impact Area - Test 10.

The airfoil was released at a rotor speed of 5000 rpm and was contained in a typical manner. It nested into the sandwich structure as shown in Figure 42 and did not penetrate the outer plies of Kevlar cloth (Figure 43). The containment case away from the impact point was not significantly affected and the rotor unbalance due to the airfoil loss was not sufficient to cause the blade tips to rub on the casing. It was considered that this test was a successful demonstration of the lightweight containment concept as it would be applied to a commercial application having the energy absorbing requirement exemplified by the test.
